EVALUATION OF THE

750,000 Gallon Steel Elevated Water Tank

Brazil, Indiana

March 22, 2004

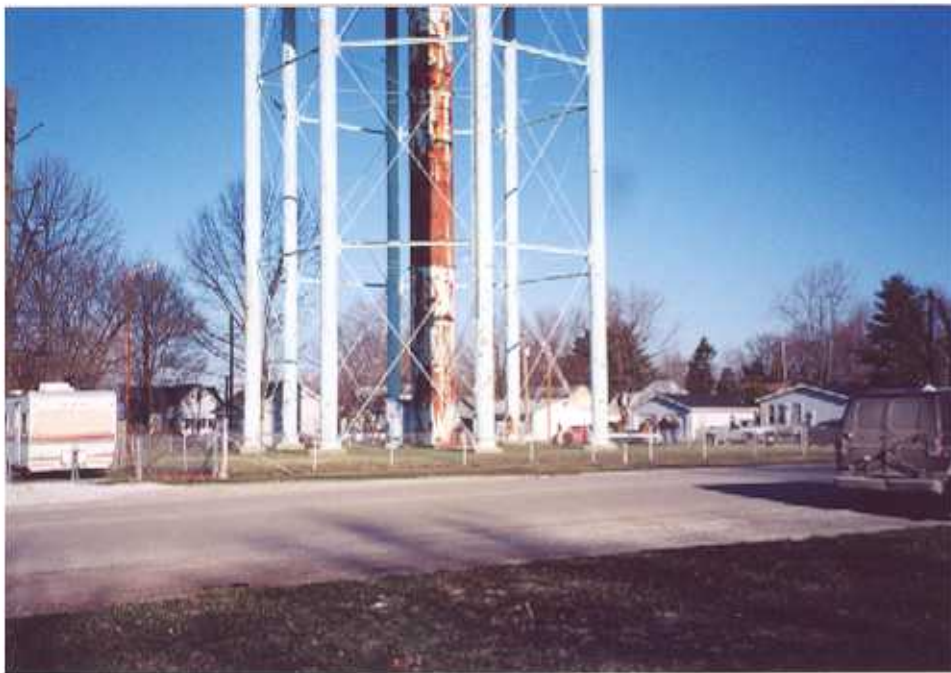
7. Tank site.

2. **Site Conditions:** The tank site was covered with grass and appeared to be graded to provide adequate drainage away from the foundations. The tank site was fenced. The chain link fence was topped with barbed wire and was equipped with a double gate on the north side of the site. The barbed wire was angled inward at the top of the fence. Some broken strands of barbed wire were noted at the southwest corner, southeast corner, and approximate center of the south side of the site. Overhead power lines were located southwest of the tank and at light poles south and north-northwest of the tank. An overhead electrical line extended underneath the tank to a telemetry building adjacent to the riser. (See photos 7-8, 15-16, 29)

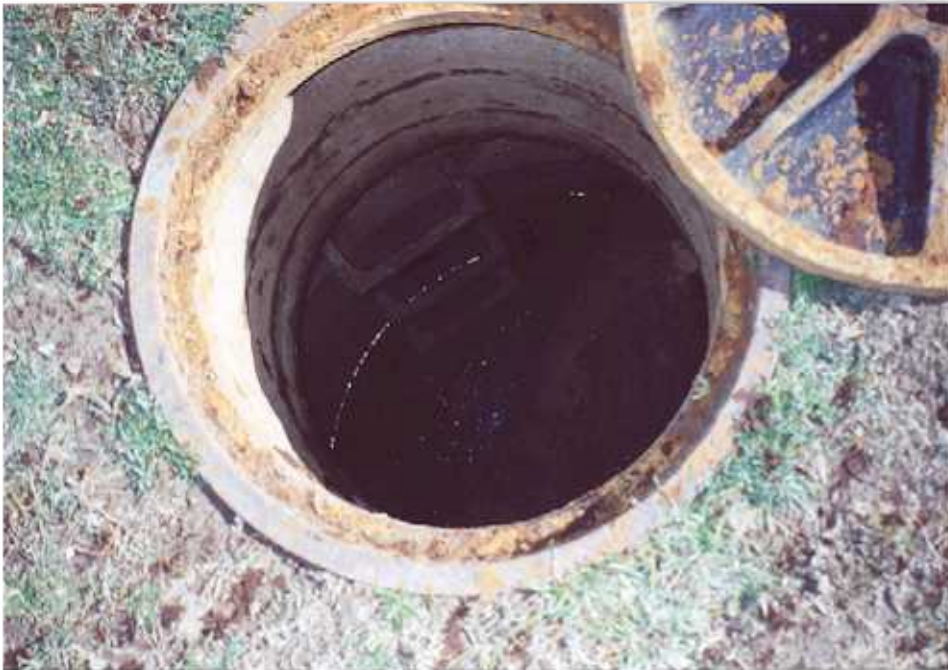
9. Access to vault.

4. **Vault:** There were safety and OSHA deficiencies noted: (1) the rung width of 9 in. did not meet the required 16 in. minimum, (2) the 5 in. toe room did not meet the required 7 in. minimum, (3) the ladder rungs were not all spaced at consistent 12 in. intervals, and (4) the head clearance at the vault access did not meet the required 30 in. minimum. There was a vault located north of the riser. Access into the vault was not locked prior to or after this field evaluation. The access was equipped with an iron cover. The vault contained a tap into the inlet/outlet pipe for the telemetry located inside the building west of the riser. Water was observed in the bottom of the vault. Valve boxes were also located on site. (See photos 9-10)

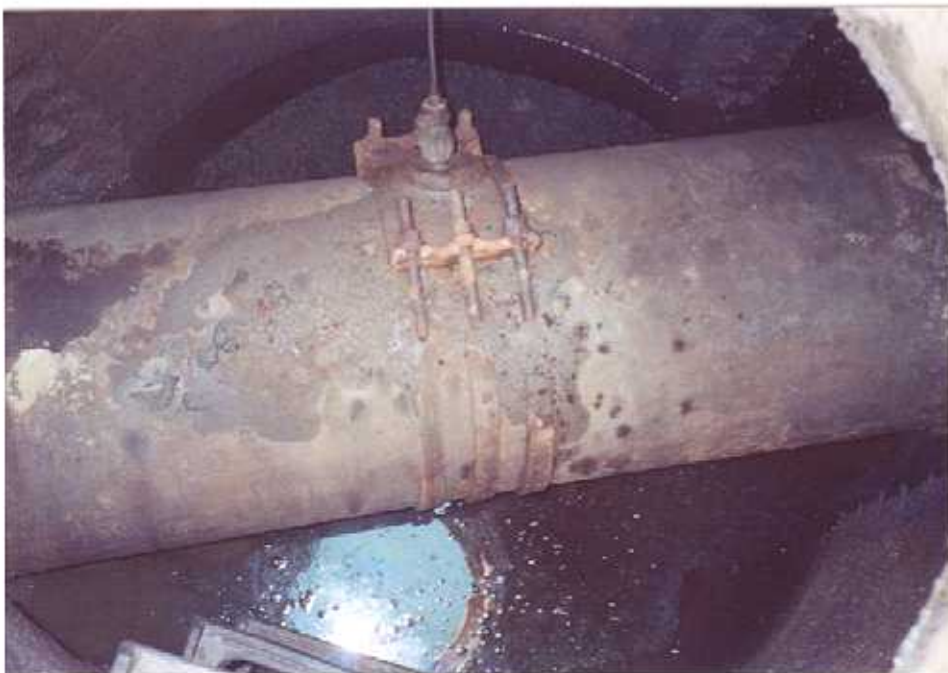
10. Inlet/outlet pipe with tap for telemetry inside vault.

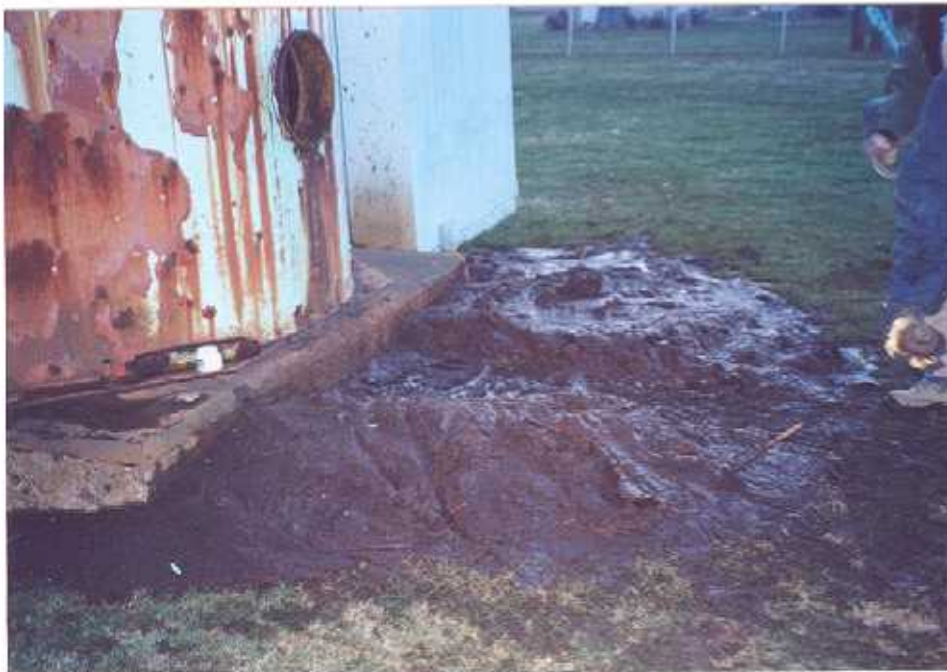
14. Sludge removed from tank interior.

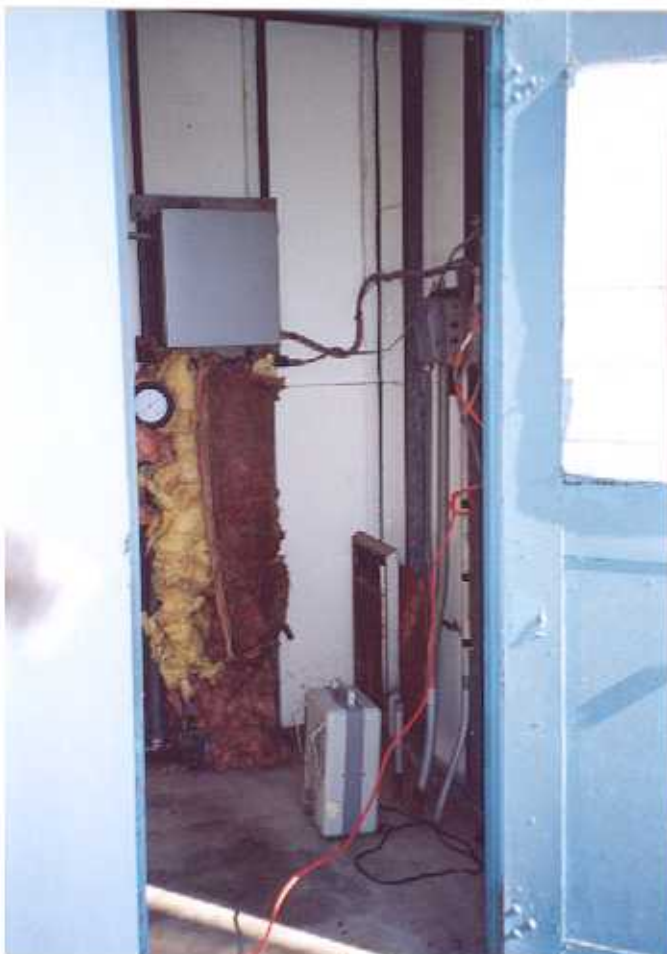
16. Telemetry cabinet and heater inside building adjacent to riser.

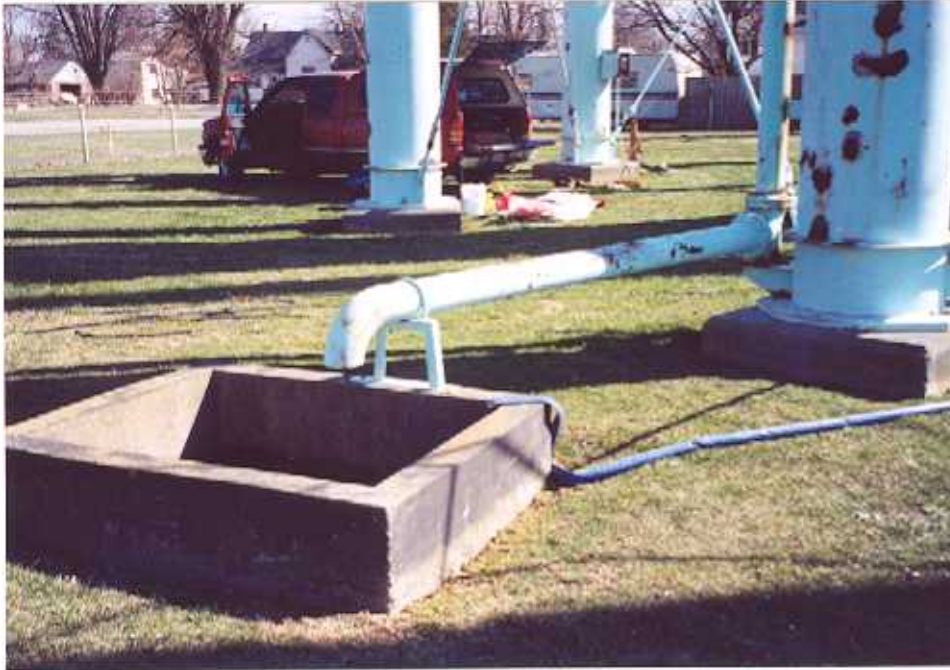
17. Overflow pipe discharge into drain basin.

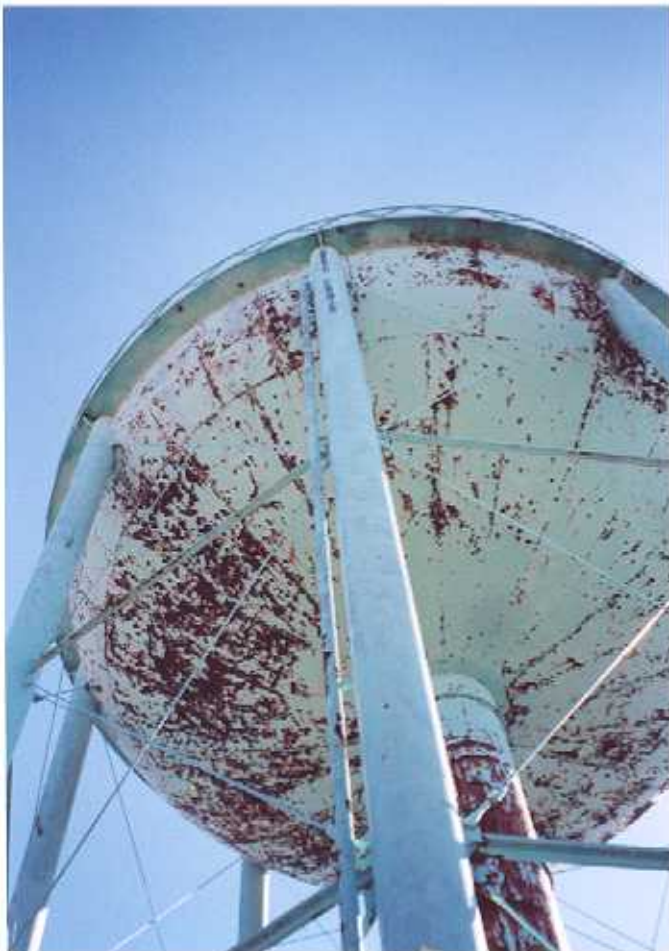
18. Overflow pipe along column. Note sign on column and rust on bowl and riser.

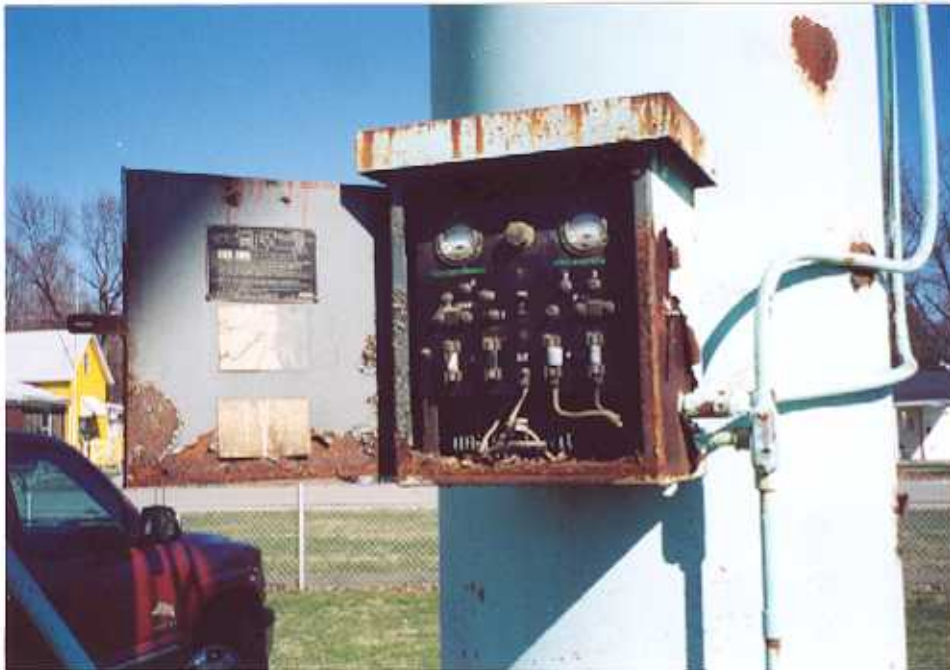
21. Cathodic protection rectifier on column.

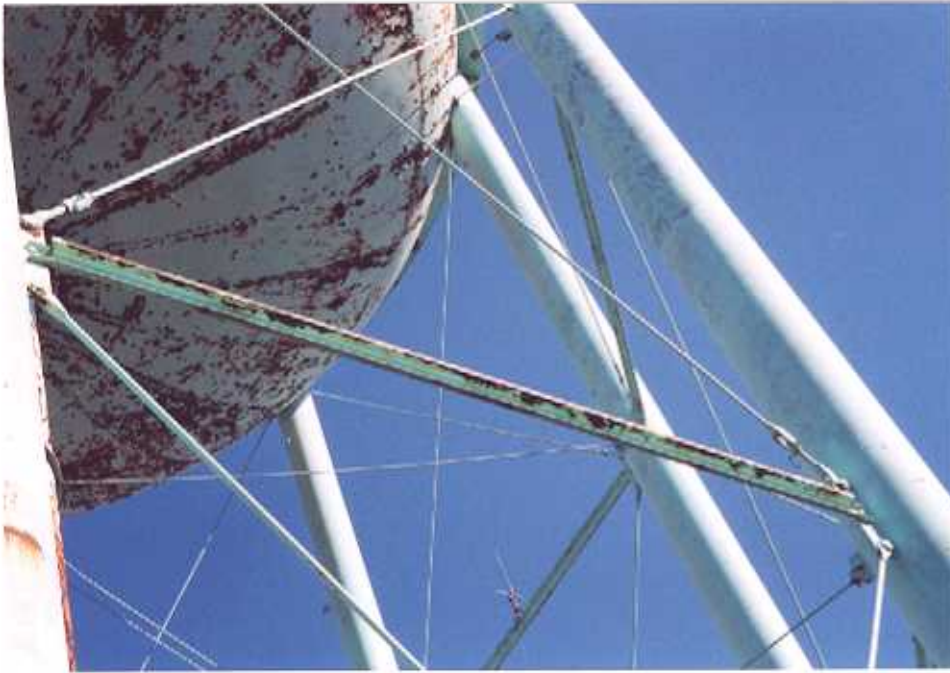
23. Columns, struts, diagonal bracing, and bowl.

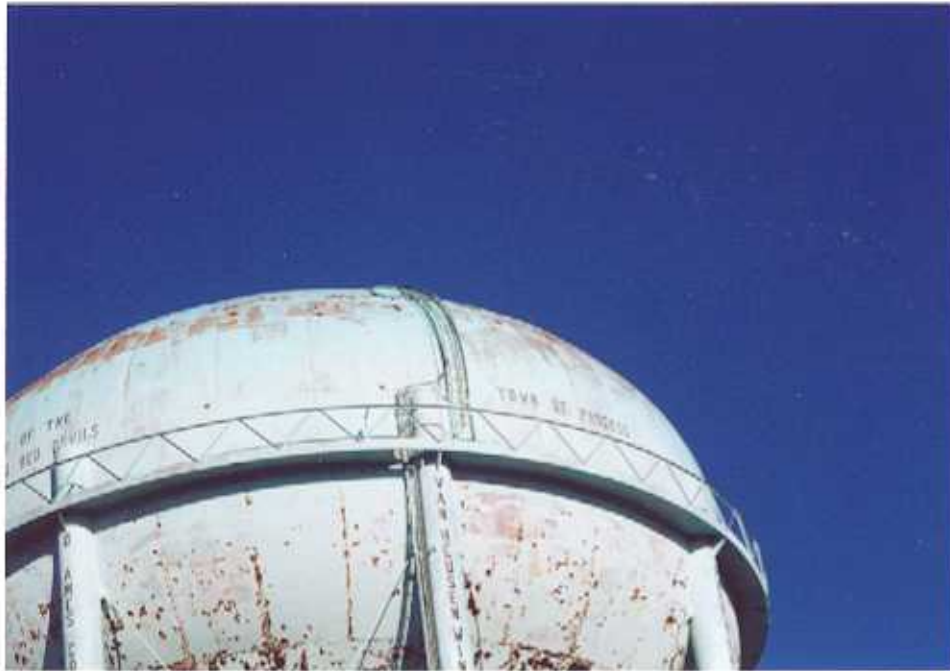
31. Container, ladders, and balcony. Note signs on tank shell and columns.

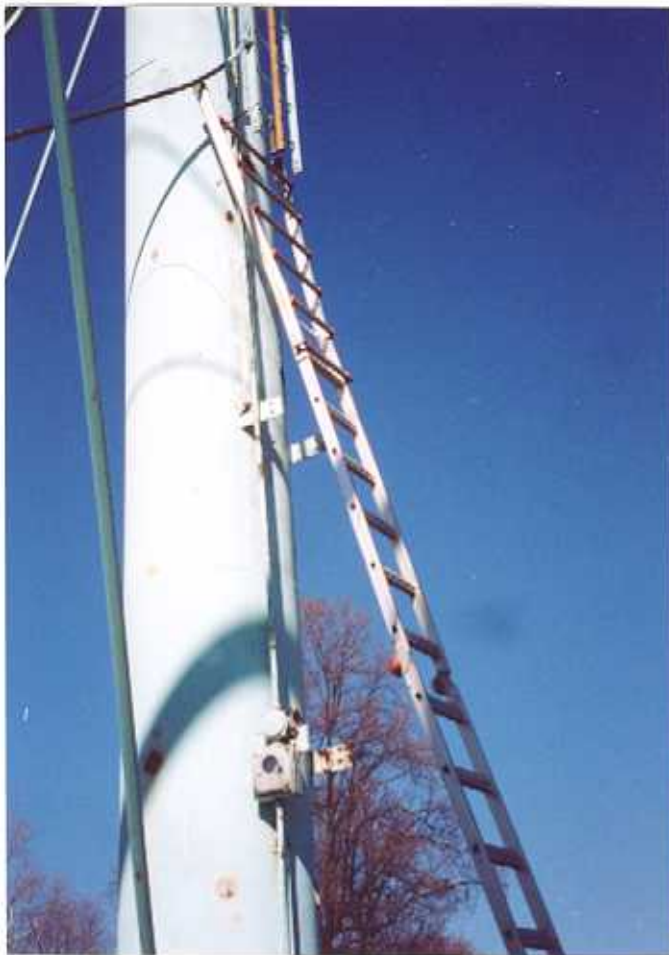
33. Photoelectric cell and brackets below tower ladder.

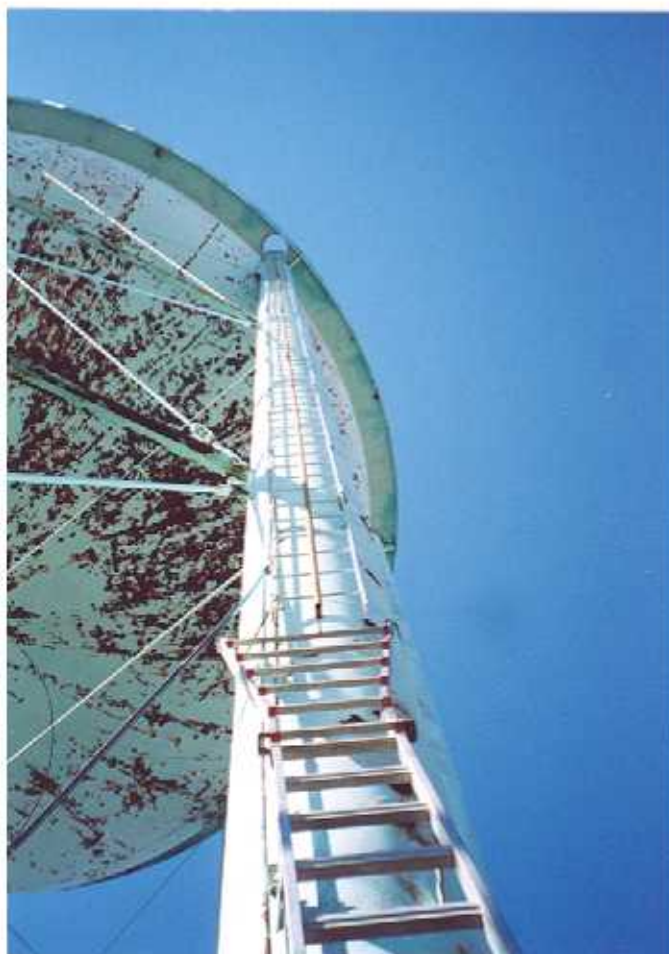
Number of Rungs: 89
Distance From Foundation to Lowest Rung: approx. 12 ft 10 in.
Width: 15 in.
Side Rails: 2 in. x 5/16 in., flat bar
Rung Size: 5/8 in. diameter
Spacing: 12 in. on center
Toe Room: 6 in.
Head Clearance at Balcony: approx. 19 in.
Brackets:
 Construction: welded to column and bolted to ladder w/ 3/4 in. diameter bolts
 Size: 4 in. x 1/4 in., flat bar x 10 in. long
 Spacing: approx. 12 ft
Safe-Climbing Device: notched-tubular rail
Vandal Deterrent: none

34. Tower ladder.

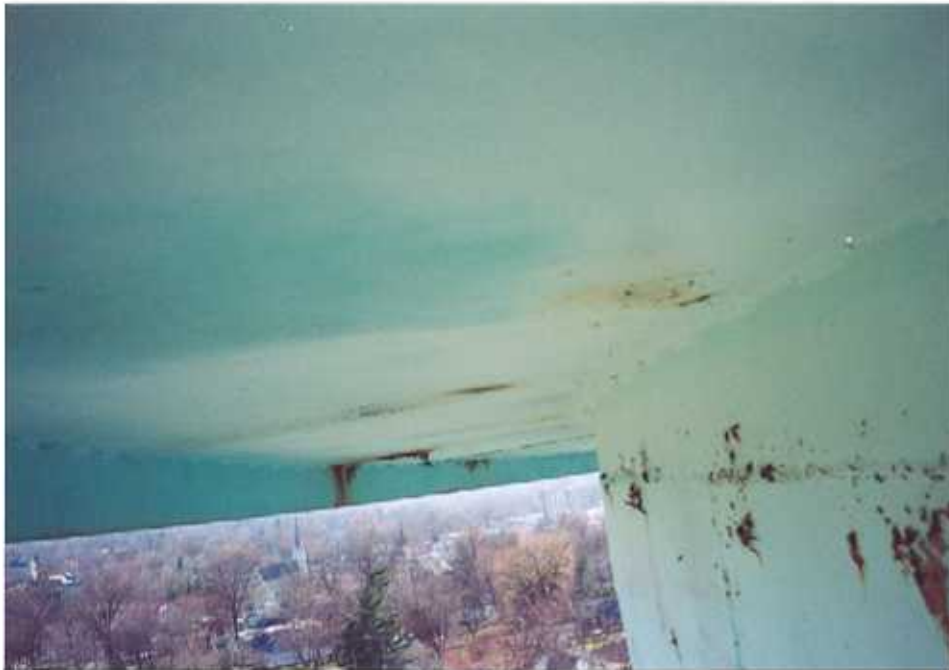
35. Underside of balcony.

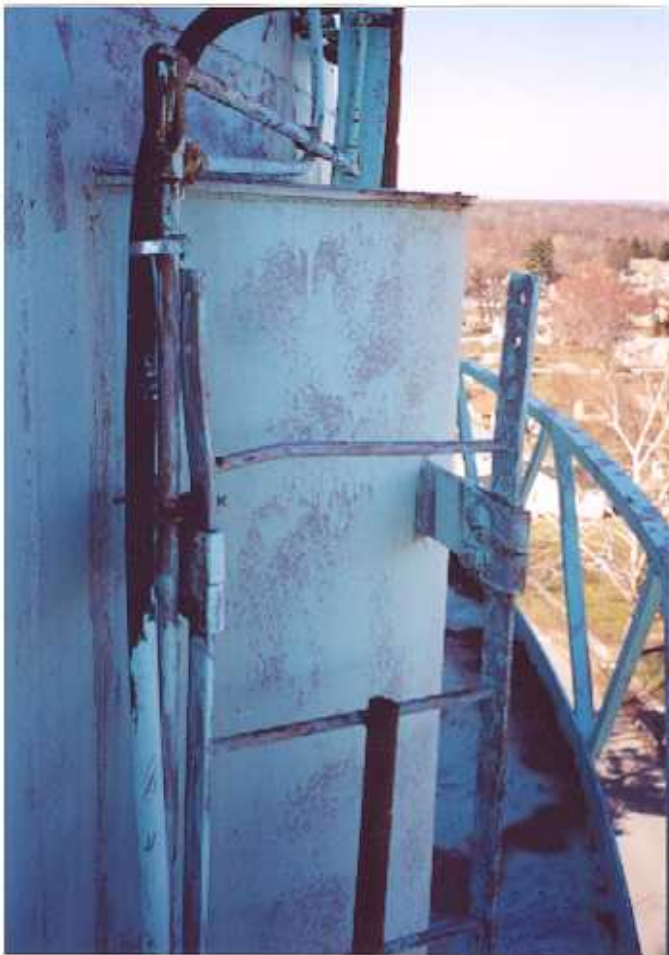
37. Tower ladder above balcony. Note conduit and cable.

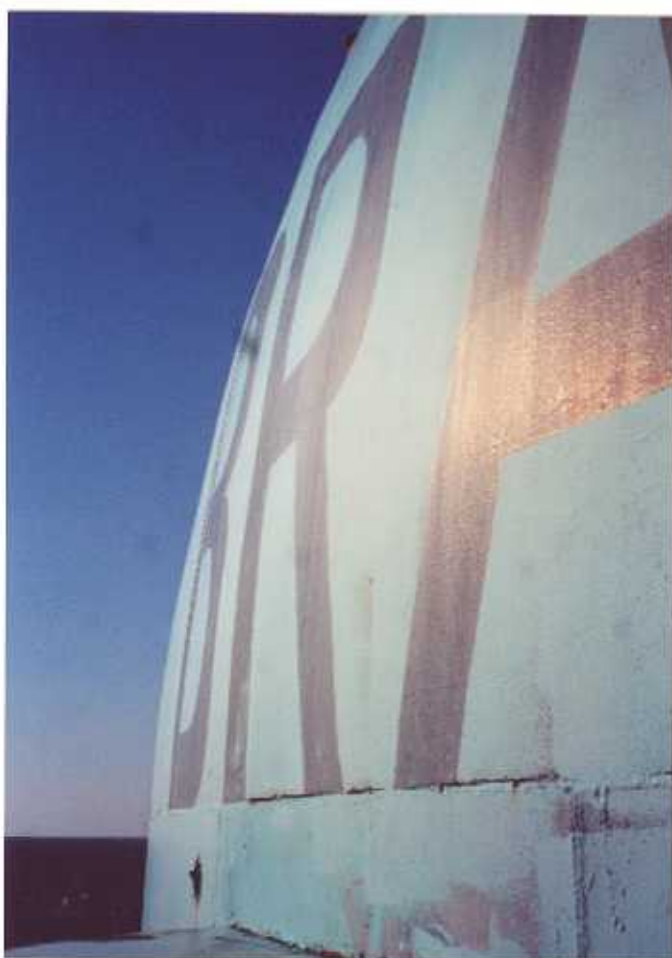
42. Sign on container.

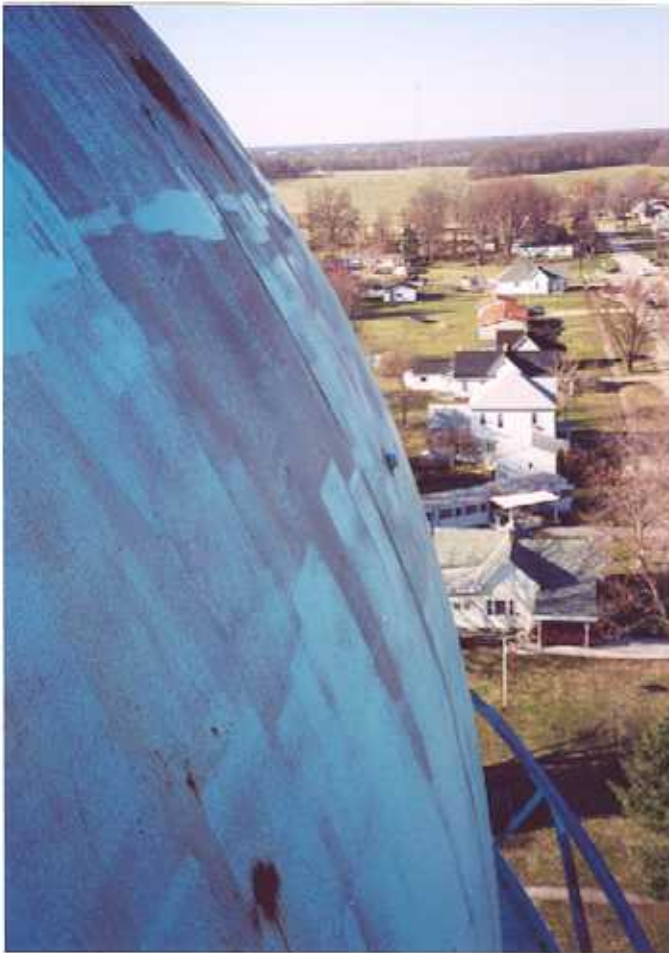
43. Chalked coating exposed underlying coating on roof knuckle.

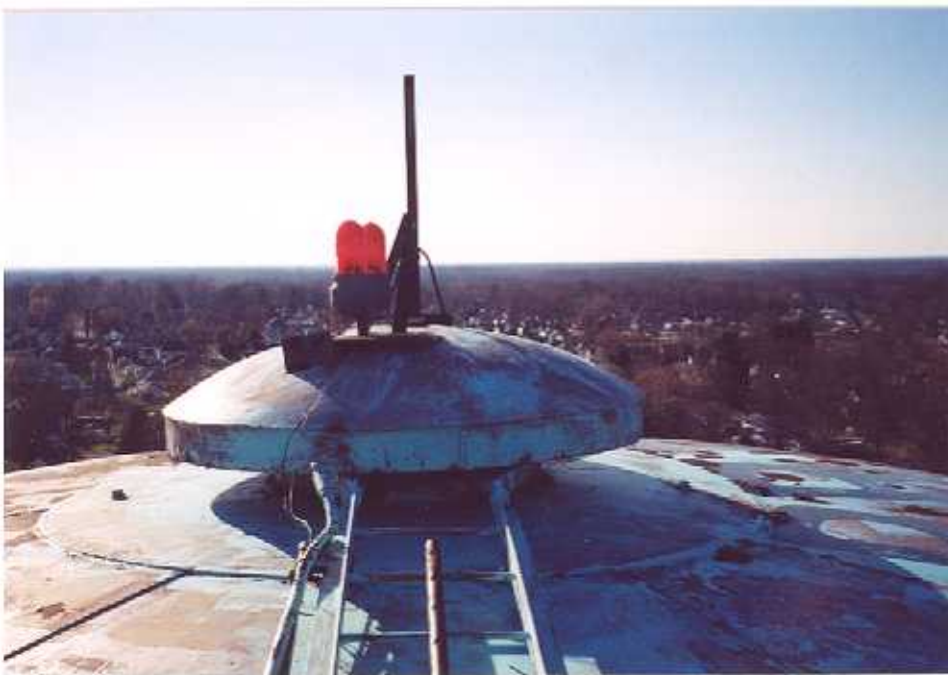
48. Roof vent, obstruction light, and antenna mounting bracket.

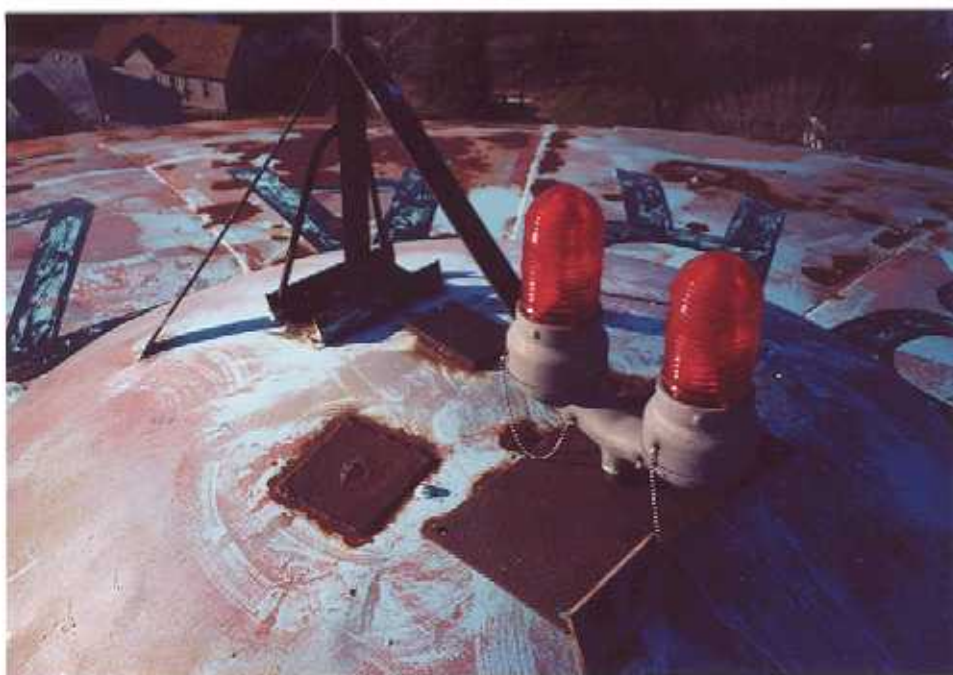
50. Roof vent cover, obstruction light, and antenna mounting bracket.

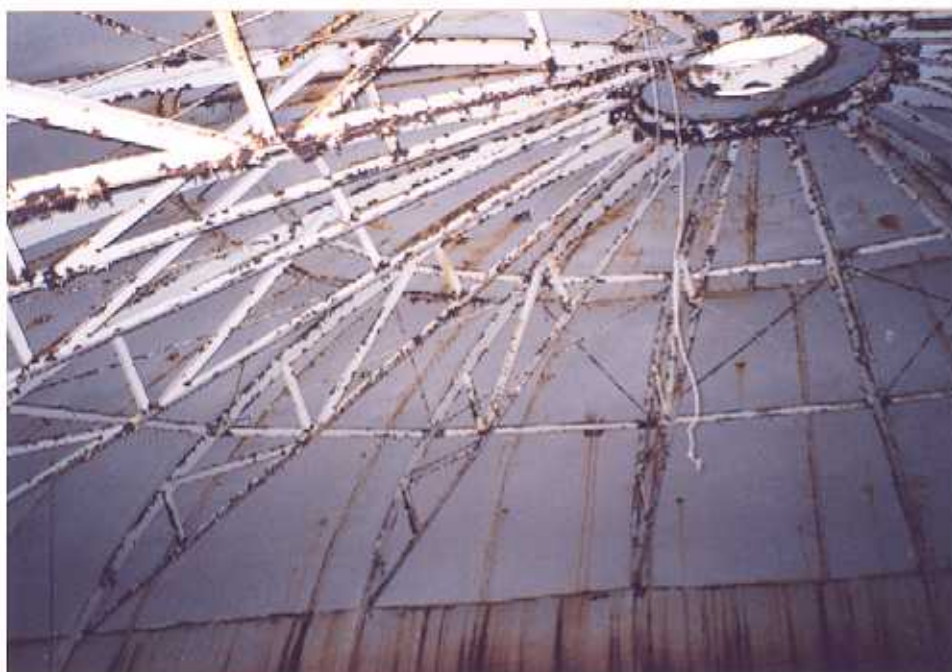
53. Interior roof structure.

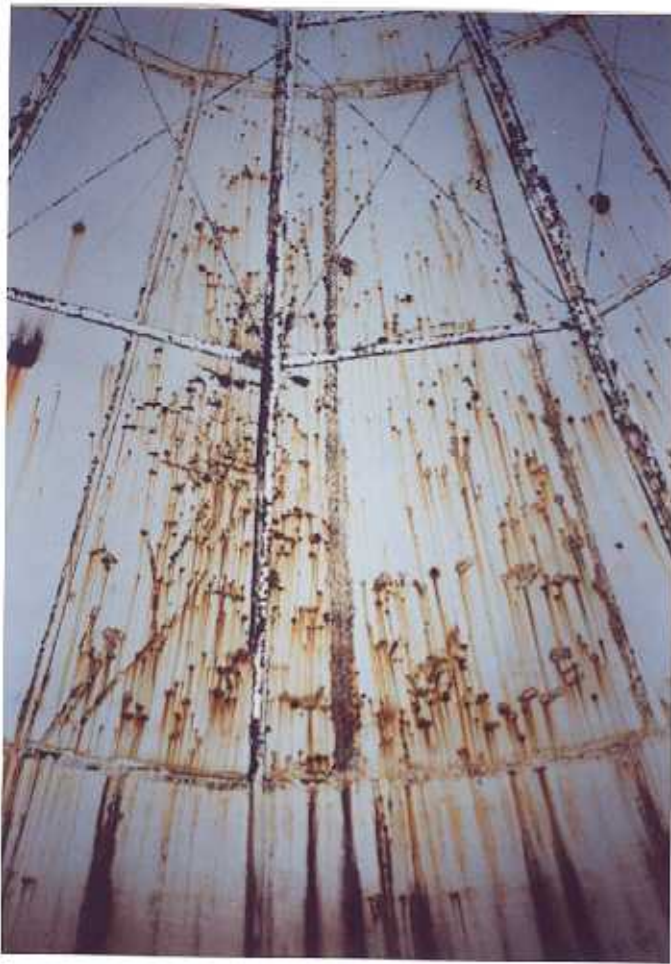
55. Interior roof structure.

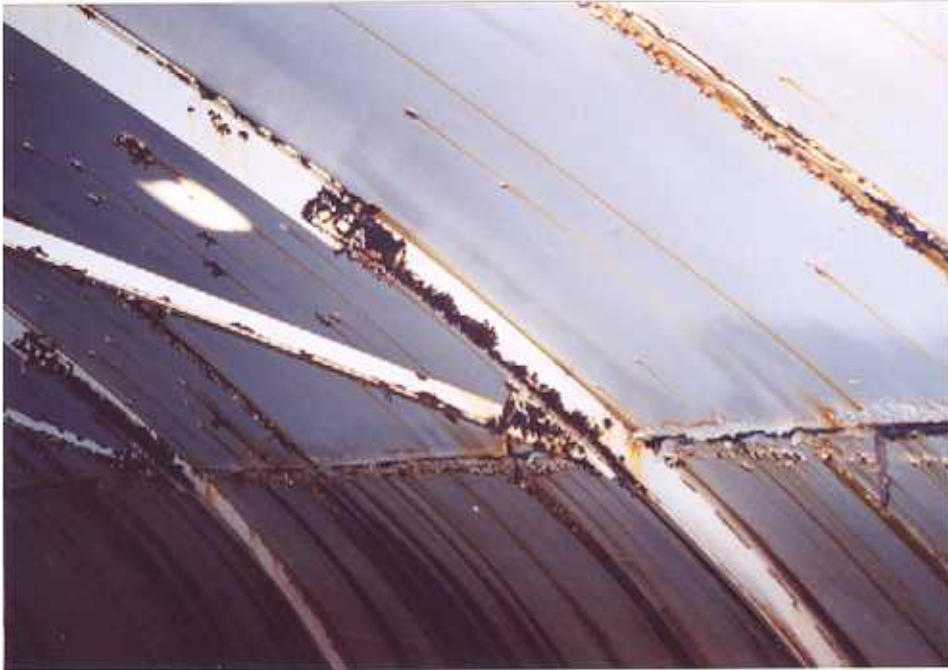
59. Roof truss connection
at top of roof knuckle.

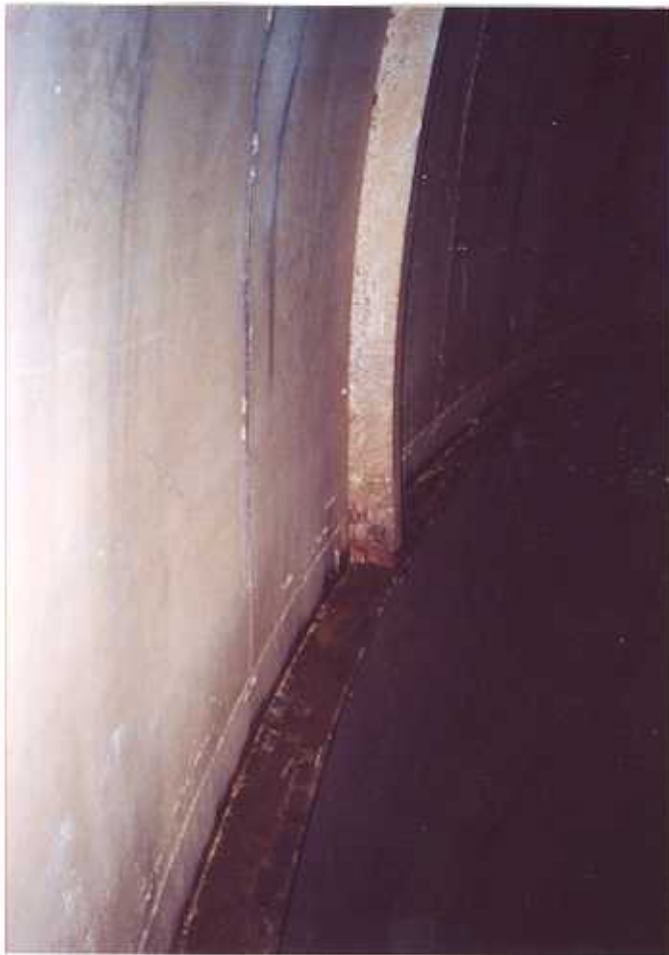
63. Roof stiffener connection to stiffener at top of shell.

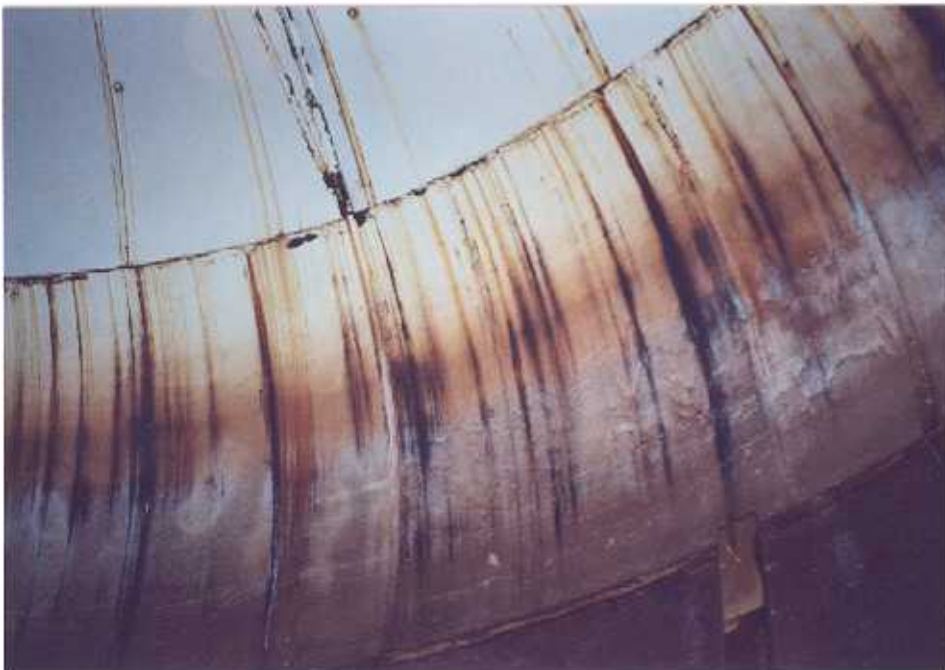
64. Interior roof and shell.

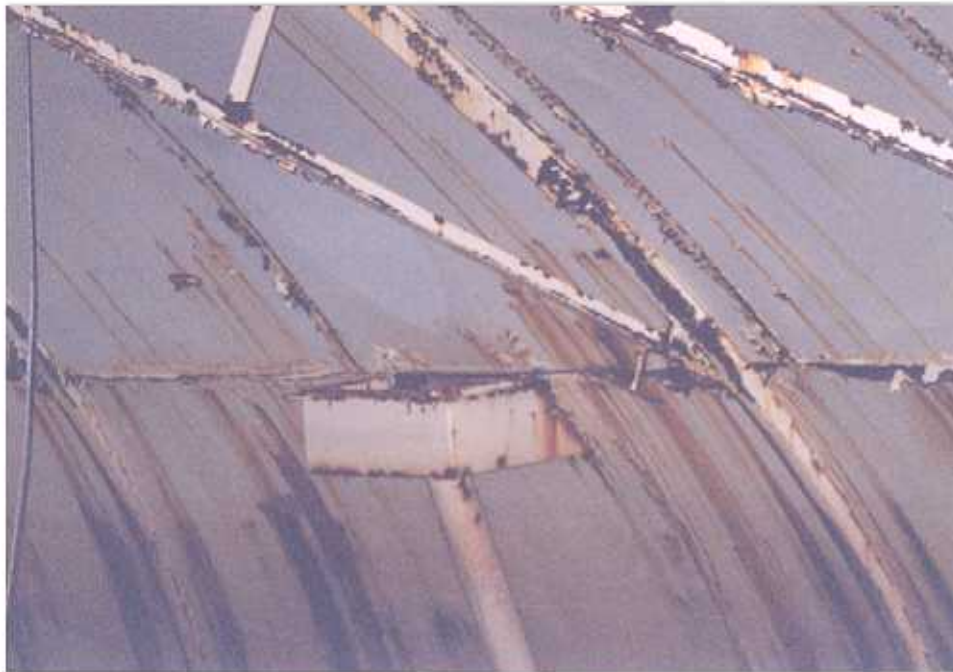
65. Overflow pipe weir box.

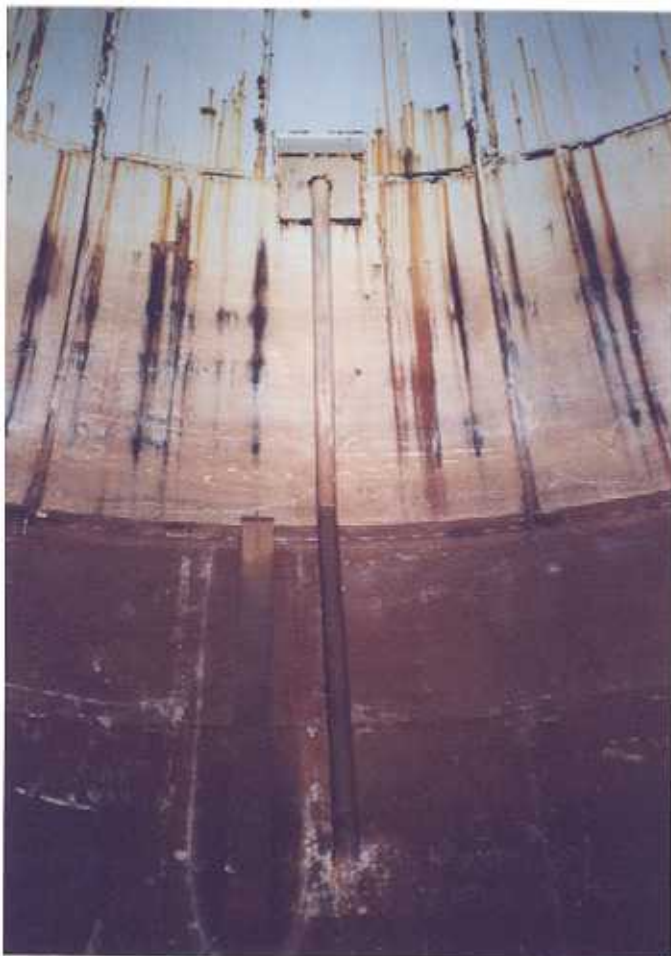
66. Interior roof, shell, overflow pipe, and weir box.

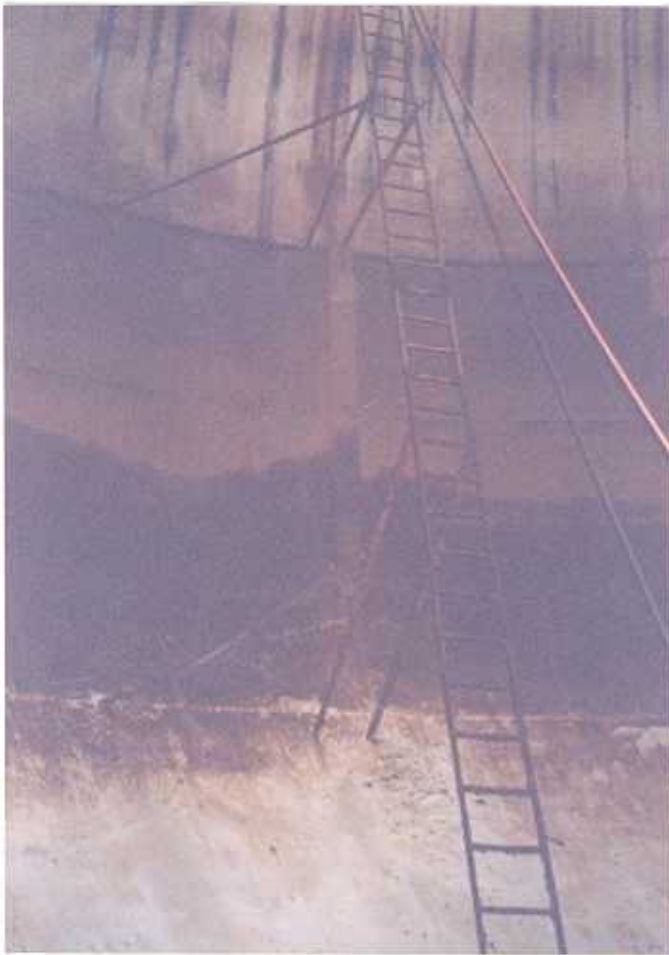
69. Interior container ladder.

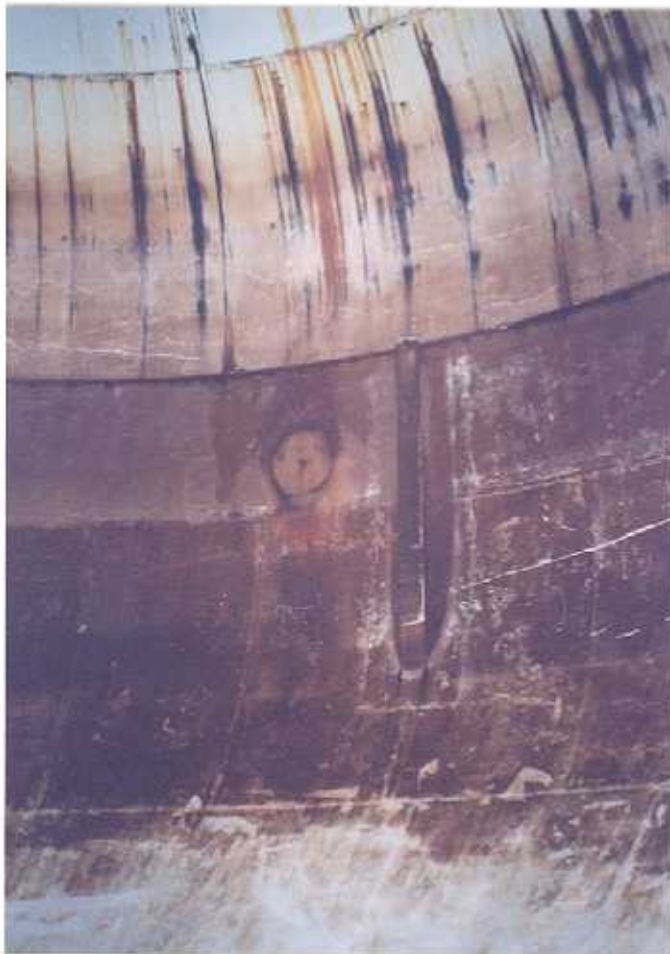
- 72. Interior roof, shell, and bowl. Note column stiffener and circular patch plate in shell.

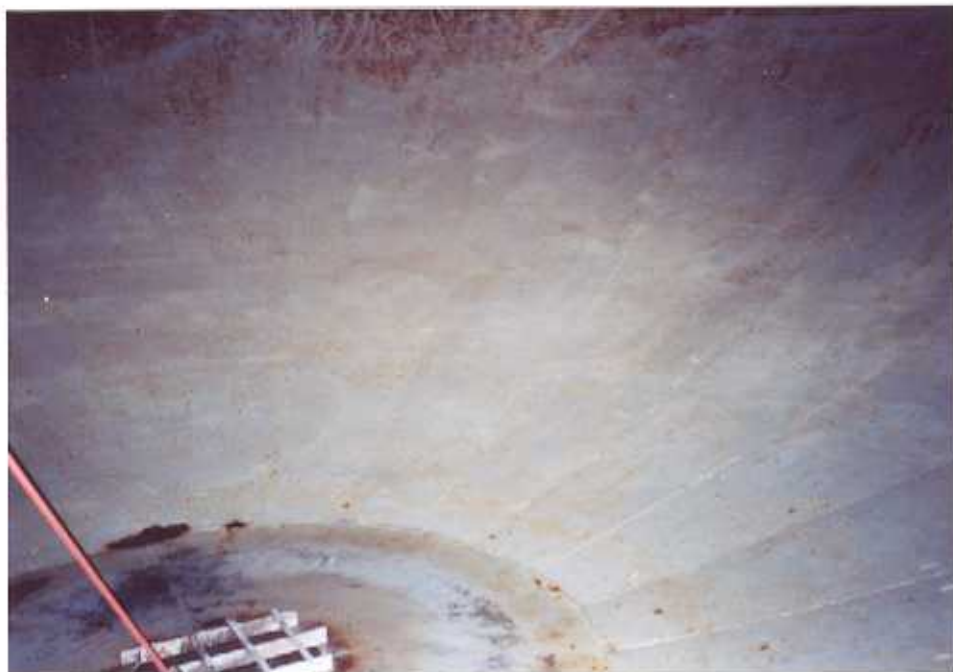
73. Interior bowl and riser safety grate.

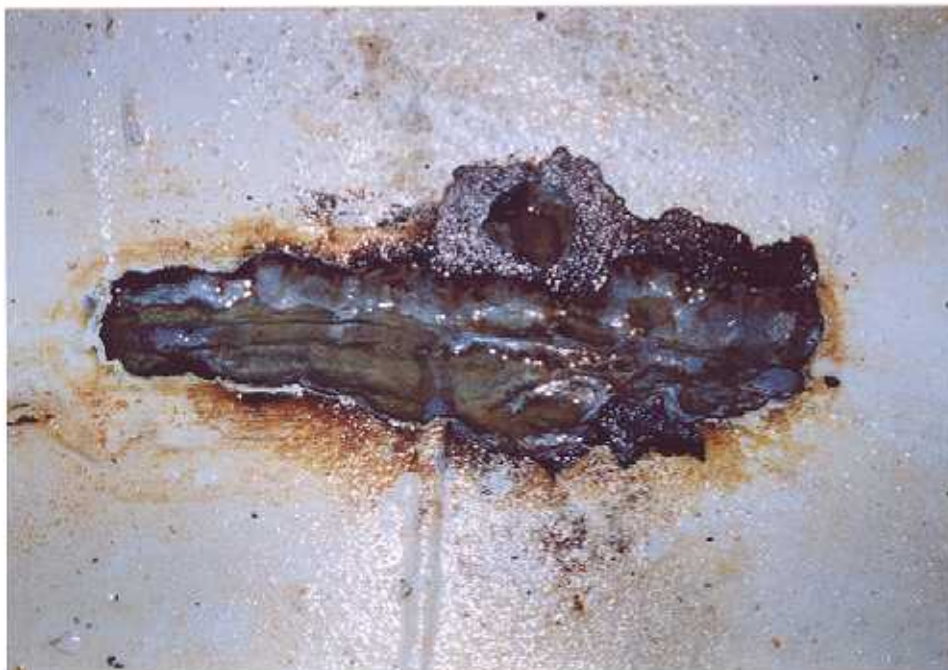
78. Pit in bowl.

Interior Coating: Due to the significant amount of rust in the roof structure and the few severe pits observed in the bowl, Tank Industry Consultants recommends that the interior surfaces of this tank should be recoated within the year. It is recommended that when the interior is completely cleaned and repainted, an epoxy coating system should be used.

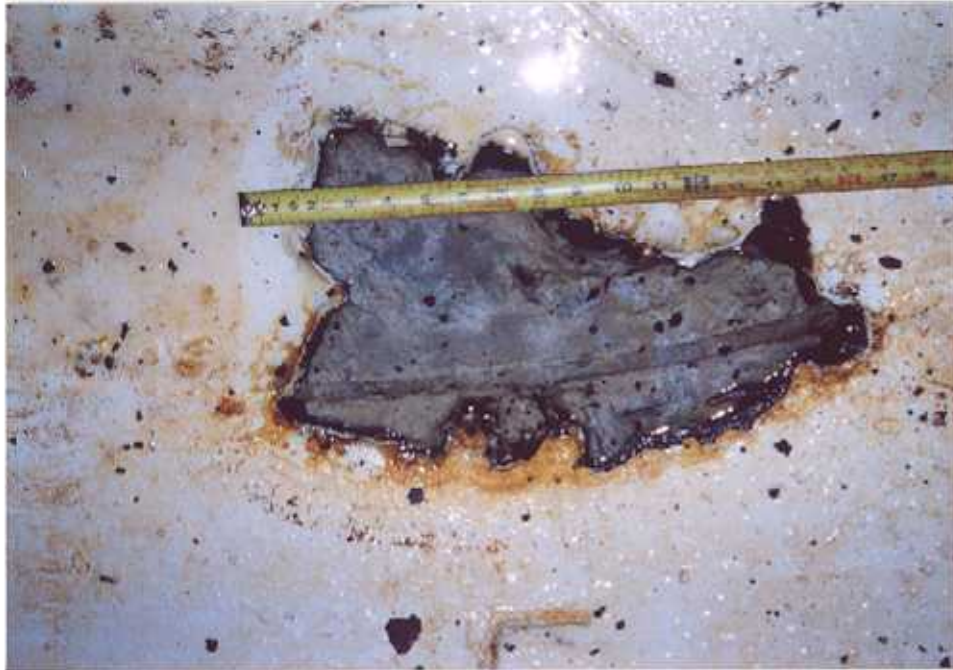
79. Pit in bowl.

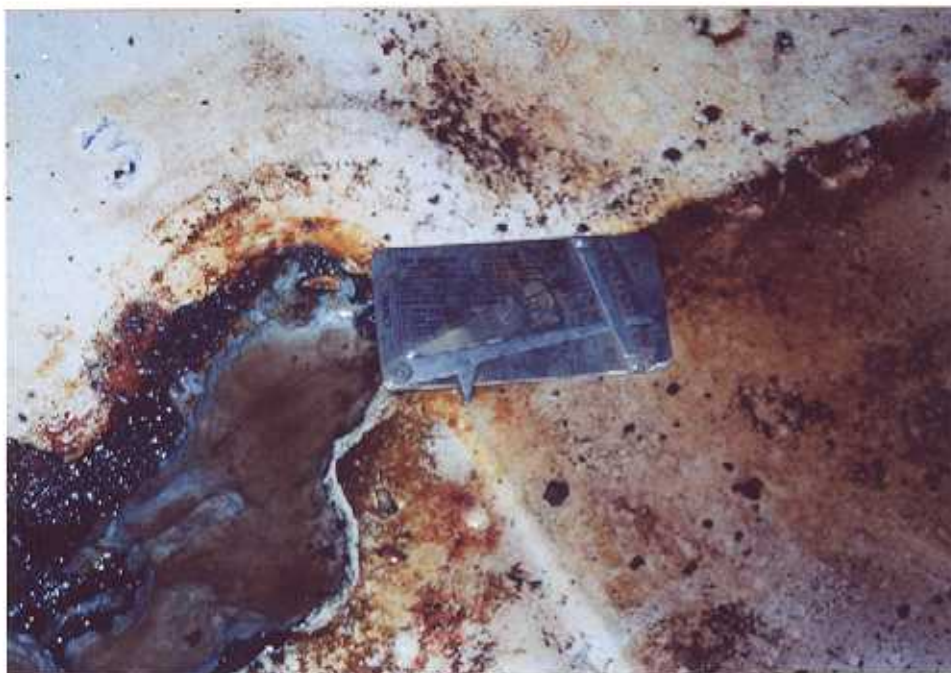
81. Pit in bowl.

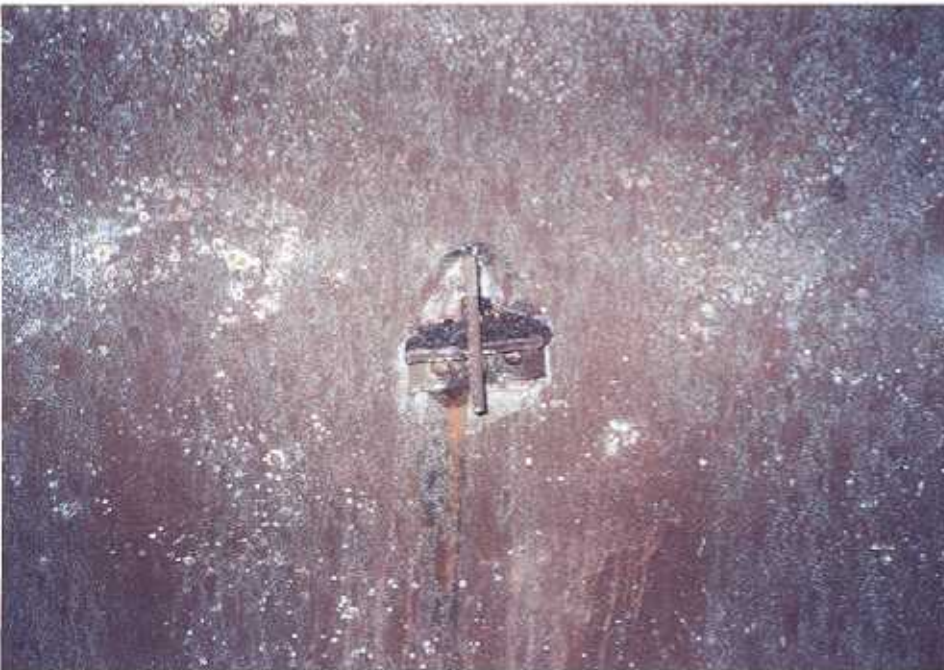
84. Bracket on interior riser.

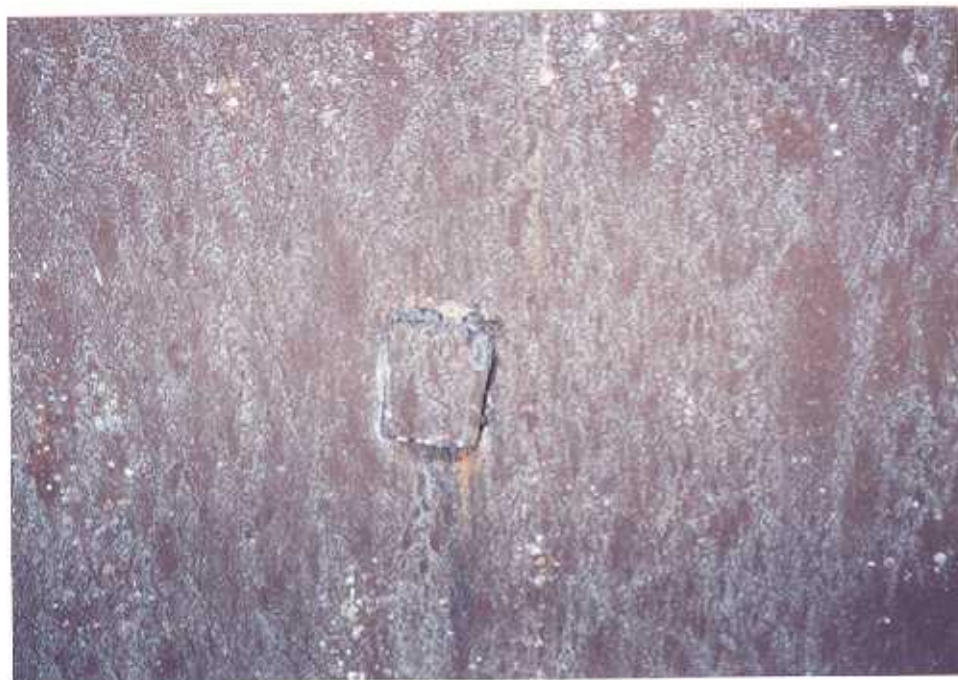
85. Bracket on interior riser.

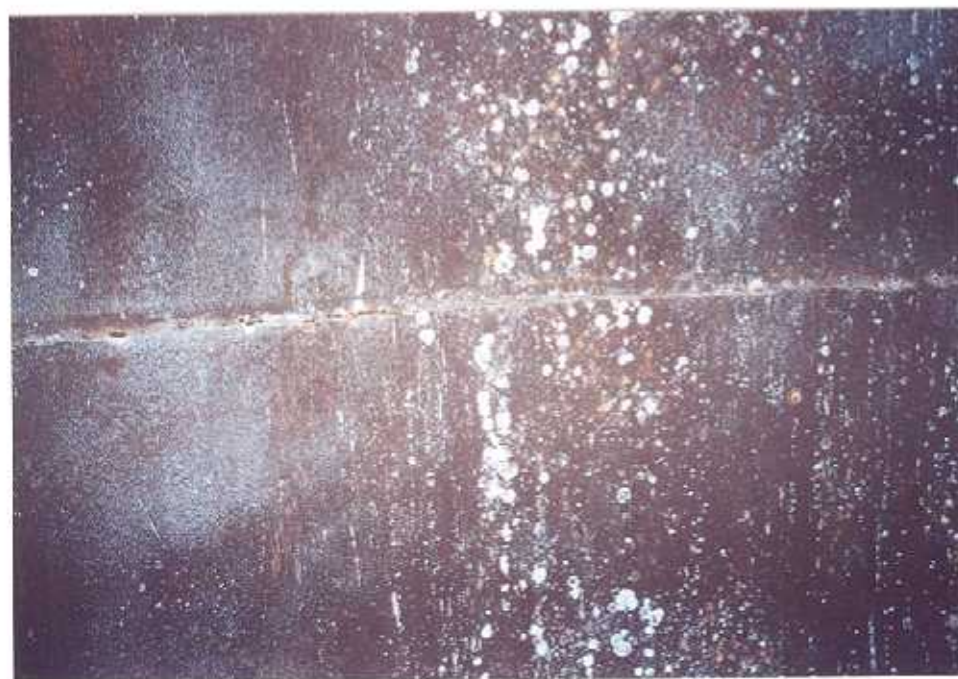
86. Interior riser.
